MECetchBOND surface treatment system

The CEMCO Streamline Range Pat Pend. horizontal processor has been configured and qualified for use with MEC™ MECetchBOND CZ-8100 chemistry at a conveyor speed of 500 – 1000mm/min.

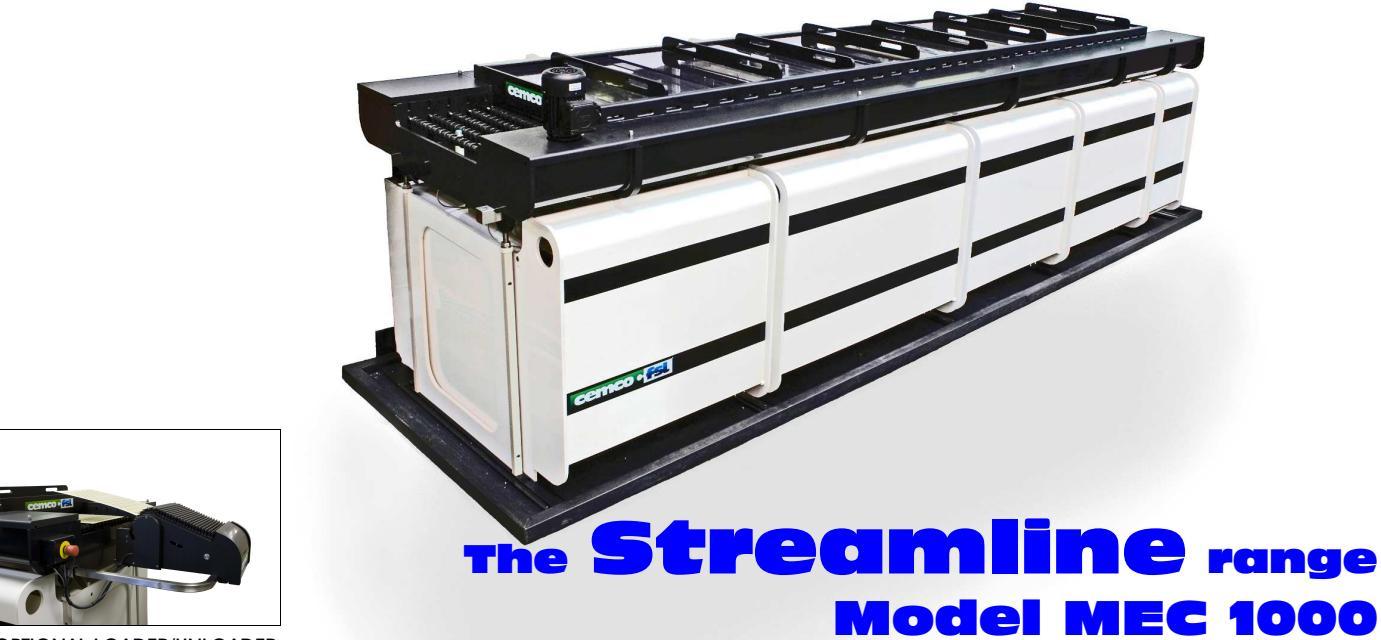
PROCESS LINE OVERVIEW

The complete, simple to use treatment system provides a superior copper surface topography for enhanced adhesion properties between the copper and Photo Polymer coatings. The system comprises pre-cleaning, pre-dip, microetch and acid rinse stages. A number of options are available including automatic dosing, loading and unloading and higher throughput capacity.

- 1. Feed Conveyor with drive motor
- 2. Pre-Clean
- 3. Three-stage Cascade Wash
- 4. Pre-dip
- 5. IMEC™ MECetchBOND CZ-8100 treatment
- 6. Two-stage Cascade Wash
- 7. Acid Rinse
- 8. Three-stage Cascade DI Wash
- 9. Panel Drier
- 10. Exit Conveyor
